**EFFECT OF HOLD TIMES ON FATIGUE BEHAVIOR OF NEXTEL™  
720/ALUMINA CERAMIC MATRIX COMPOSITE AT 1200°C IN AIR AND IN  
STEAM ENVIRONMENT**

THESIS

John M. Mehrman, Captain, USAF  
AFIT/GAE/ENY/06-M23

***AIR FORCE INSTITUTE OF TECHNOLOGY***

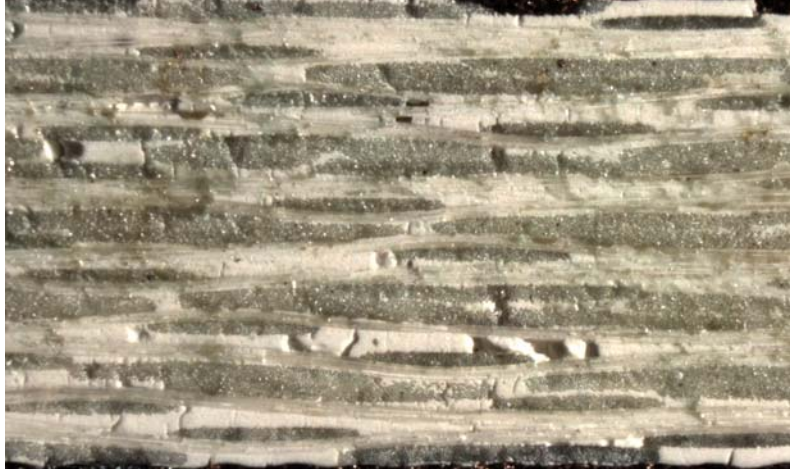
**Figure 7. Optical micrograph of polished as-received N720/A material.**

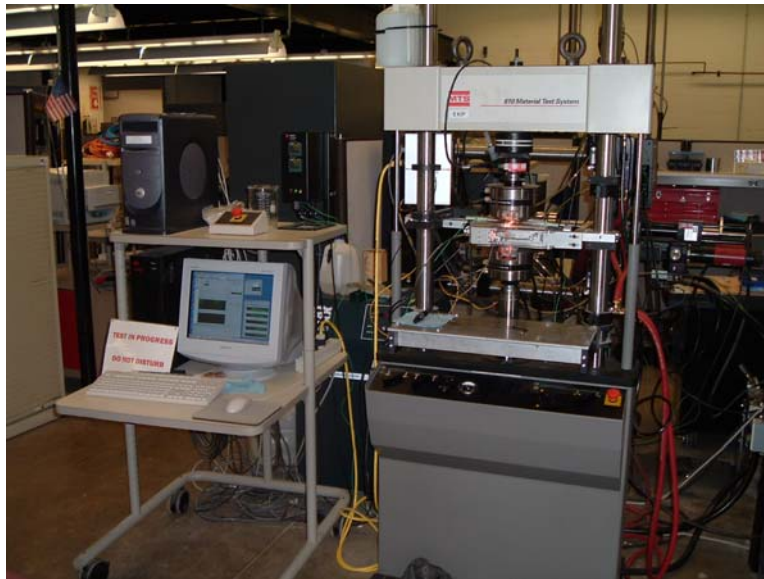
**Figure 10. Mechanical testing station.**

Figure 10 show the overall mechanical testing station set-up

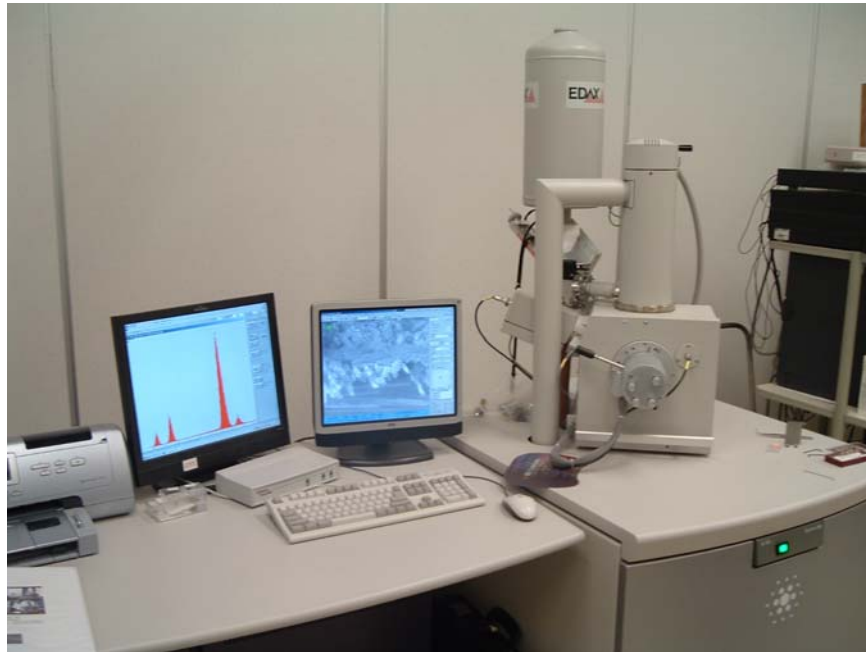
**Figure 13. FEI Scanning Electron Microscope (SEM) and EDAX Energy Dispersive X-ray Analysis Systems (EDS).**

Figure 13 shows the SEM and EDS systems.

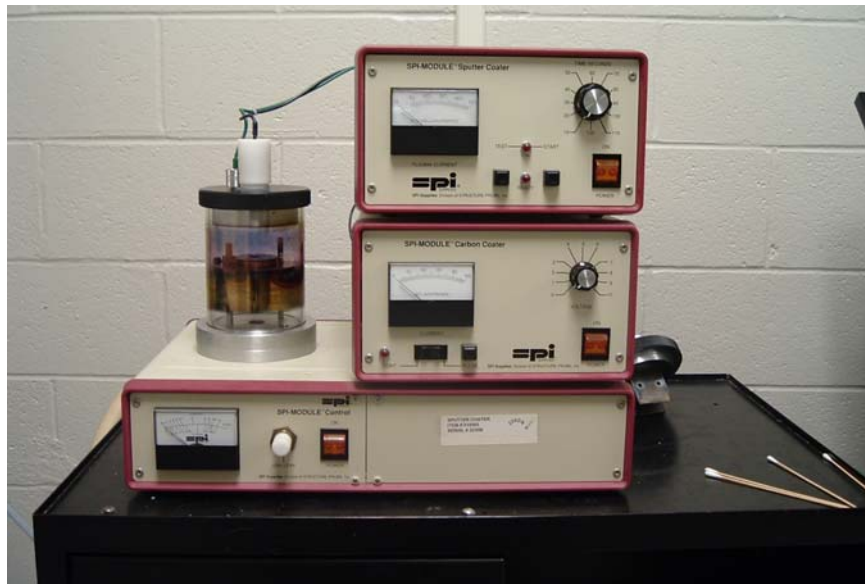
**Figure 16. SPI-Module Controller and Carbon Coater.**

Non-conductive materials like the alumina and mullite found in the Nextel 720/A CMC tend to build up a charge when bombarded by the electron beam of the SEM. This leads to distortion of the image and, if severe enough, can lead to damage of the specimen. To combat this problem, two different methods were used. The first was to coat a specimen with a thin layer of a conductive material. For this research, both carbon and gold coatings were tried out. Carbon coating was chosen based on image quality, and more importantly, because gold would have been detrimental to the spectroscopy characterization discussed later. A SPI Supplies SPI-Module Control and Carbon Coater, shown in Figure 16, were used to coat the specimens.

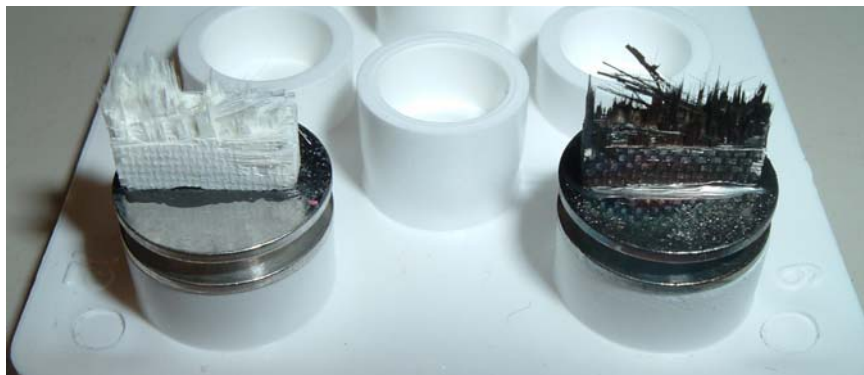
**Figure 17. Specimens prepared for SEM. Uncoated specimen on left, carbon coated specimen on right.**

Every specimen was examined in ESEM mode and digital photos were taken at various magnifications ranging from 50X to 3000X. Only a few of the specimens were coated with carbon and observed at higher magnifications in high vacuum mode. Figure 17 shows two specimens prepared for examination in the SEM. The specimen on the left is uncoated and the specimen on the right is carbon coated.

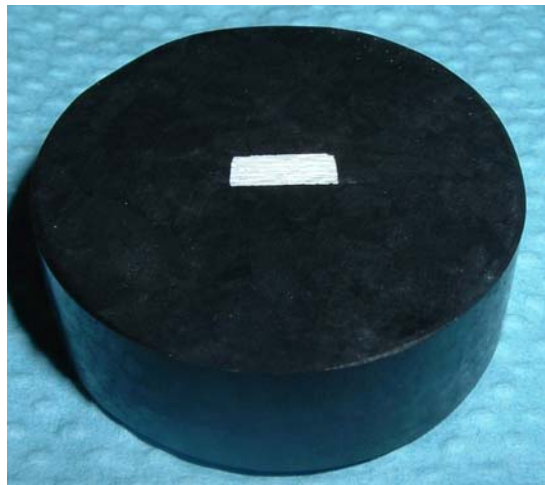
**Figure 18. Mounted and polished N720/A specimen.**

Untested N720/A CMC was mounted in a carbon resin fill and polished for viewing with the optical microscope as well as the SEM. A Buehler Simplimet 2000 automatic mounting press was used to mount the specimen in a Buehler Konductomet conductive filled phenolic mounting compound. The specimen was then polished with a Buehler PowerPro 5000 variable speed grinder and polisher. The specimen was first ground with 240(60  $\mu\text{m}$ ) , 400(30  $\mu\text{m}$ ), and then 600(15  $\mu\text{m}$ ) grit sandpapers. Then it was polished with 6 $\mu\text{m}$ , 1 $\mu\text{m}$ , 0.1 $\mu\text{m}$ , and lastly 0.05 $\mu\text{m}$  Buehler Metadi diamond suspension paste. Lastly, it was carbon coated using the SPI Supplies SPI-Module Control and Carbon Coater mentioned above. Figure 18 shows a picture of the mounted and polished specimen prior to carbon coating.
